TECHNICAL REPORT REMR-CS-16

REPAIR OF DAM INTAKE STRUCTURES AND CONDUITS. CASE HISTORIES

Roy L. Campbell, Sr., Dennis L. Bean

January 1988

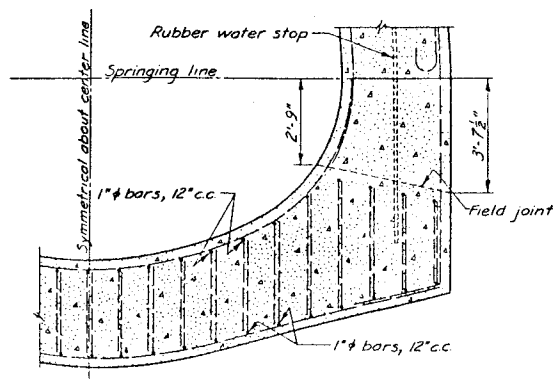
Figure 2. Waterstop location in joint, Arkabutla Dam

9. Arkabutla Dam was completed in 1943 and is located in northwestern Mississippi on the Coldwater River approximately 12 miles northwest of Coldwater, Mississippi, in the Vicksburg District. The main dam is a rolled earthfill embankment approximately 10,700 ft long with a maximum height of 67 ft above the valley floor. The outlet works is located near the south abutment of the main dam. It consists of reinforced concrete structures that include an approach channel, three-gate control structure, transition, single-barrel conduit, chute, and stilling basin. The conduit is made up of thirteen 25 ft monoliths each having a modified inverted egg-shaped cross section (Figure 1) that is 18.25 ft high and 16 ft wide with a ring thickness of 3 ft at the crown and 3.5 ft at the spring line and invert. The monolith joints of the conduit have 9-in. rubber water stops in the crown and side walls that extend below field joint, but not into the invert (Figure 2).

10. It appears that the omission of water stops in the invert is the major contributing factor in the leakage and associated deficiencies observed at the monolith joints of the conduit. During the early operations of the outlet works, leakage was observed at the upstream joints between monoliths 1 and 7. Leakage continued after remedial grouting in 1950 and was accompanied by loss of foundation material and differential movement. Movements of 0.04 ft or greater were reported in 1969 for monolith joints 3/4, 6/7, 9/10, and 10/11. Also reported were spalling and missing filler at various joint locations. Remedial grouting of all conduit joints was performed in 1970. In 1974, a sinkhole developed in the embankment above the downstream end of the conduit near the west edge of the toe road. This sinkhole was cleaned out and backfilled with sandy clay after an investigation concluded that the sinkhole had developed from earlier foundation material losses through openings which were grouted in 1970. Leakage continued and remedial grouting was performed in 1977. In total, leakage has occurred to varying degrees at all monoliths

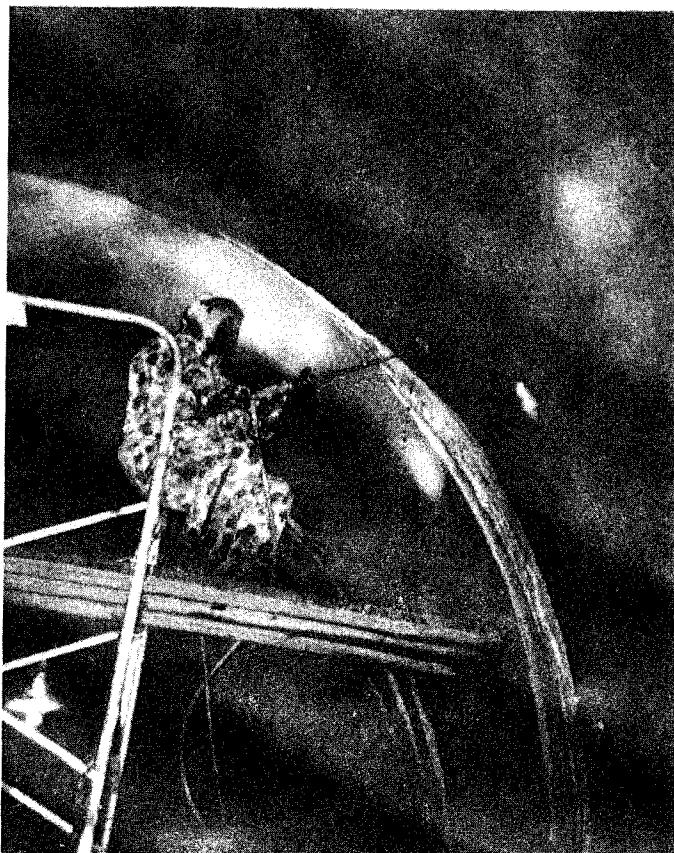
Figure 15. Drilling of grout hole, Blakely Mountain Dam, 1986

73. Holes to be drilled were measured from the center of crown along the tunnel circumference and marked. Drilling of the grout holes (Figure 15) was started on 30 January 1986 at monolith joint 20/21. The joint was weeping at two locations, 9.5 ft right of the centerline of the crown and 5 ft left of the centerline of the crown looking downstream. Five holes were located as follows: 5 ft right (weeping), 7.5 ft right (flowed), 7.5 ft left (flowed), 5 ft left (weeping), and 2.5 ft left (flowed). These grout holes were drilled at a 40- to 45-deg angle to the concrete surface and slanted toward the joint with the holes starting 12 to 16 in. downstream of the joint. The purpose for this was to intercept the joint behind the water stop so that the surface of the joint would not have to be sealed to retain the chemical grout. To drill a 30-in.-deep hole required 45 min to 1 hr. This length of time was required frequent withdrawal of the bit to assist in the removal of the cuttings and the additional effort required to puncture the water stop. Bits were not vented to blow cuttings out of the hole.

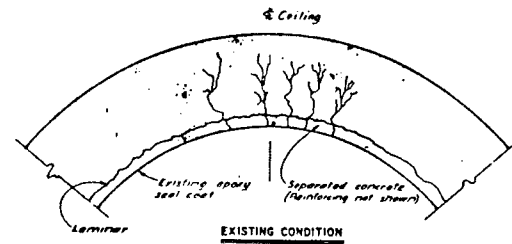
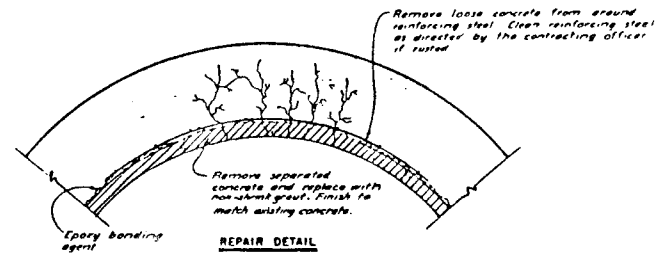
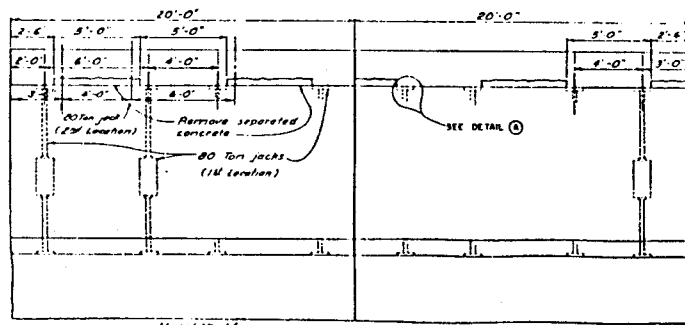
Figure 33. Details of removal and replacement concrete in crown of conduit, Eau Galle Dam

122. In a few of the monoliths containing the most severely delaminated concrete, the damaged concrete in the crown of the conduit was removed and

replaced with a nonshrink grout prior to installation of the steel liner (Figure 33). The work was performed in reaches of 5 ft and required 80-ton jacks at the ends of each reach to support the ceiling during the repair. The specifications for the nonshrink grout required aluminum powder as expansive agent, No. 4 maximum size aggregate, Type III portland cement, and minimum compressive strength of 4,200 psi.

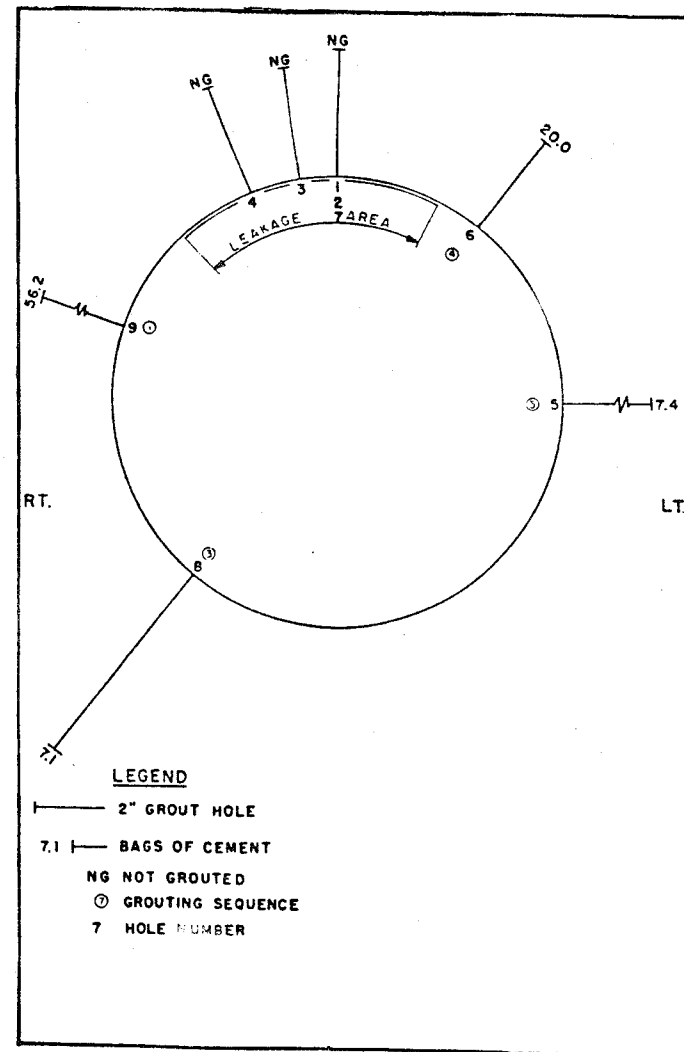
Figure 49. Details of grouting for joint 8/9,
Pine Creek Dam, 1976

207. The 5-gpm flow from the left spring line leak at monolith joint 2/3 was reduced to 2 gpm or less. The flow from the joint 8/9 was approximately 15 to 20 gpm. This was reduced to 1 gpm or less. A total of 133.3 sacks of cement or 173.1 cu ft of grout were used at the two joints. Total cost of repair was estimated to be \$8,000.

206. Four holes were drilled near the left spring line at monolith joint 2/3; three of the holes were grouted with 42.6 sacks of cement or 55.25 cu ft of grout. Nine holes were drilled around the joint 8/9, with the majority drilled on the upstream side; four of the holes were grouted with 90.7 sacks of cement or 119.85 cu ft of grout. Figures 48 and 49 show drill hole locations, grout takes, and grouting sequence for joints 2/3 and 8/9.

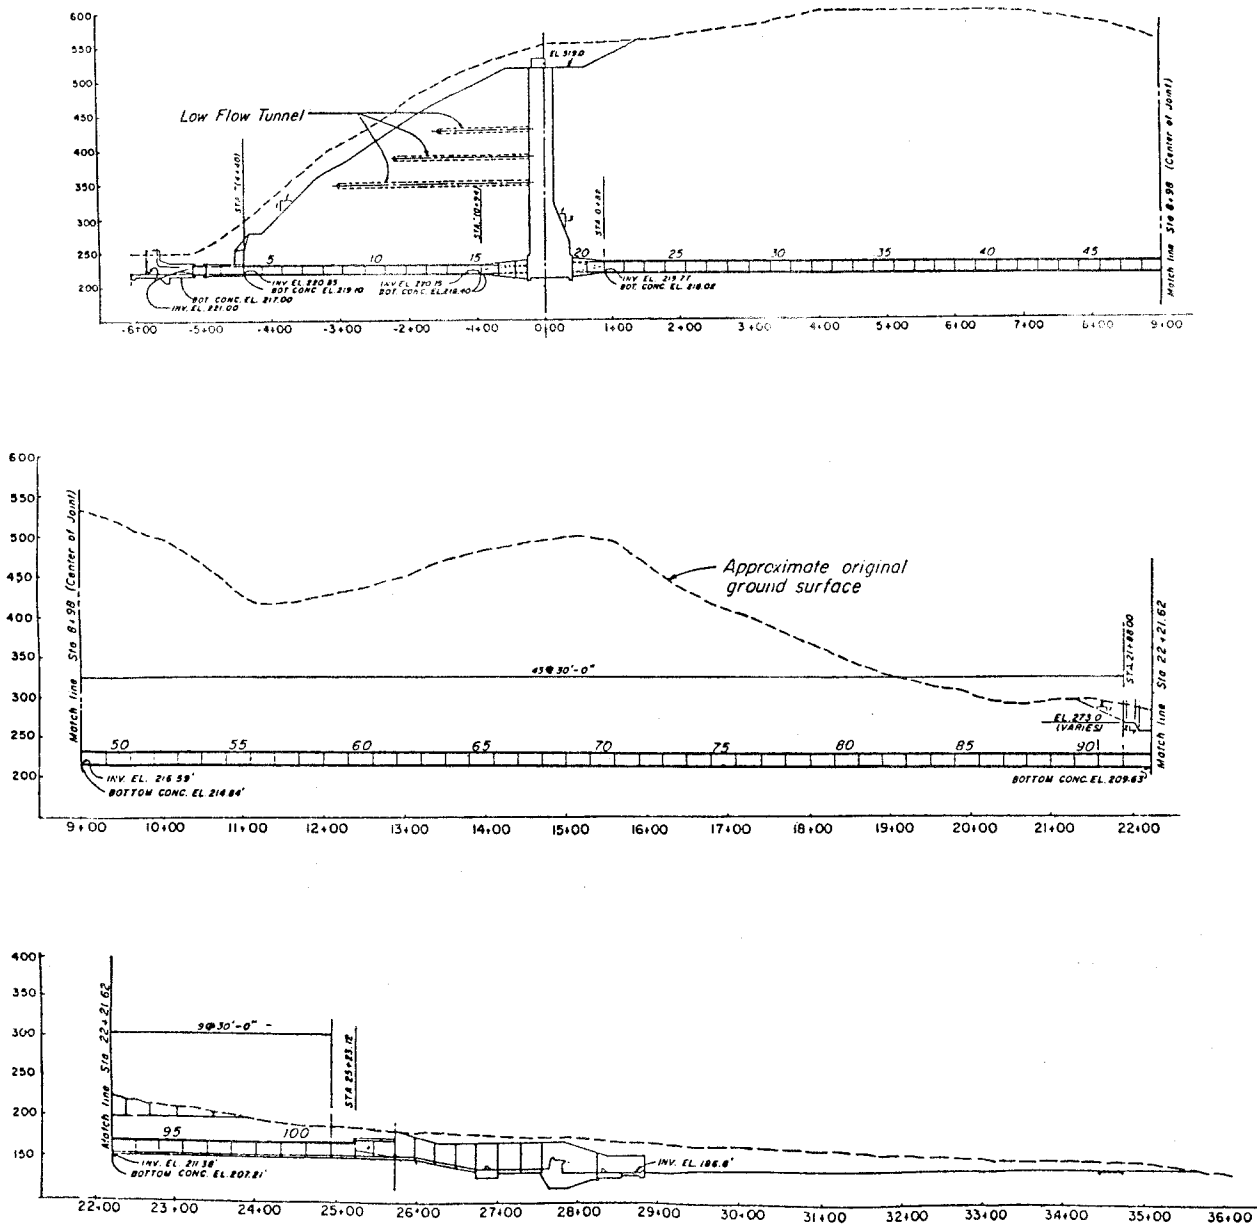
Figure 50. Centerline profile of outlet works, Warm Springs Dam

213. Leakage from horizontal construction joints and vertical cracks in the wall of the intake control structure was noted during the first periodic inspection in November of 1982. Groundwater was the leakage source since the embankment of the dam had just been completed and no water had been impounded. The extent of the leakage at the joints was highly variable, ranging from very slight, isolated flows covering 0.5 ft to 3 ft of the joint to much heavier flows wetting virtually the entire joint circumference. Many of the vertical cracks were essentially continuous across horizontal construction joints and extended over 100 ft in length. At the lower levels substantial portions of the interior surface were continuously wet and at many locations covered with mineral deposits and efflorescence. The floors at these levels were ponding water.

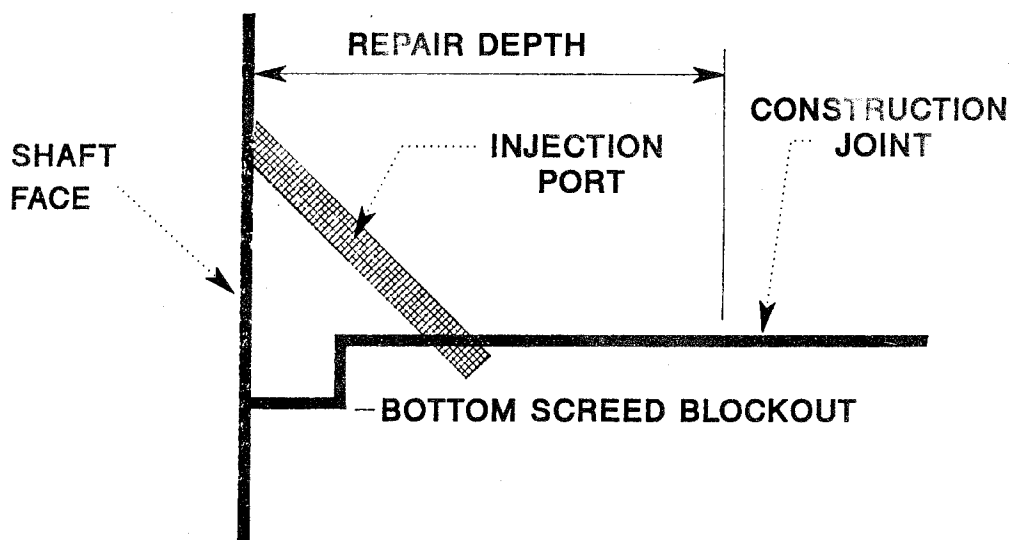
Figure 52. Sketch of epoxy injection joint detail, Warm Springs Dam

218. Only small volumes of epoxy could be injected at the horizontal ports indicating limited penetration of the epoxy into the joints. The contractor improved the penetration of the epoxy into the joints by drilling 10-in.-deep injection ports at a 45-deg incline to shaft face. These ports were located above each joint such that they intersected the horizontal portion of the joint above the assumed blockout (Figure 52).

219. After the epoxy had cured long enough to preclude its draining out from the injected voids, the pipe nipples were removed and the ports patched with Waterplug. The ports and sealed surfaces were then ground flush with the adjacent concrete surfaces.
